FACILITY REPAIR & RESTORATION:

EXISTING CONDITIONS TO BE REPAIRED & RESTORED

ST. VITAL PUBLIC LIBRARY

6 FERMOR AVENUE

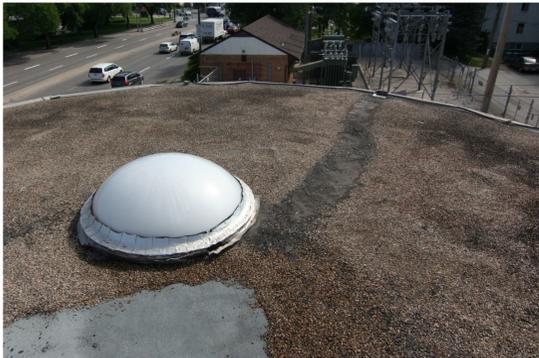
EXISTING HIGH ROOF

New roofing is an important upgrade of the 2016 renovation and will improve library building sustainability. The new roof will also allow the library to meet current standards for roof insulation values.

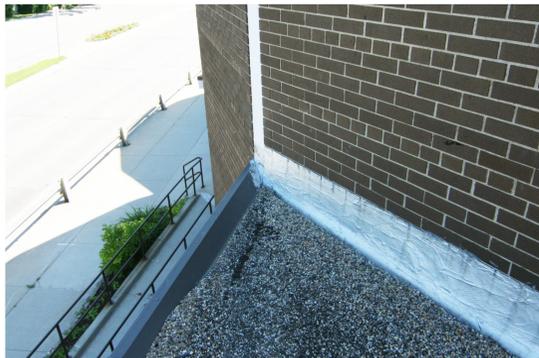
EXISTING PARAPET DETAIL AT LOW ROOF

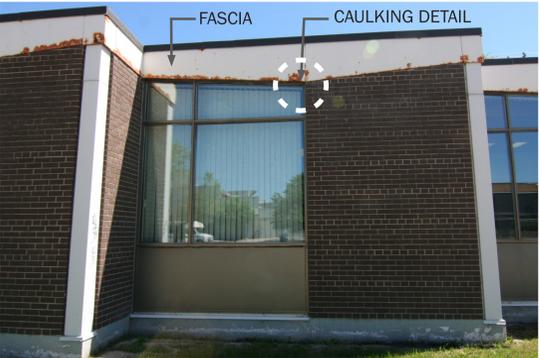
TYPICAL WINDOW DETAIL AT NORTH ELEVATION

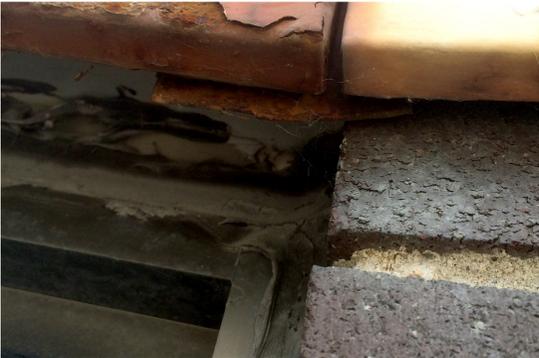
EXISTING CAULKING FAILURE AT WINDOW

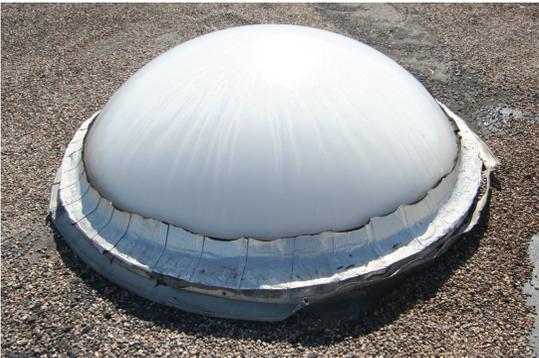
EXISTING ROUND SKYLIGHT

Skylights contribute to the character and quality of natural light at the St. Vital Library. These original features have deteriorated over time and will be replaced with new skylights produced by the same manufacturer of the originals. Contemporary details, primarily a 1'-0" parapet, are intended to improve the performance of the skylights.

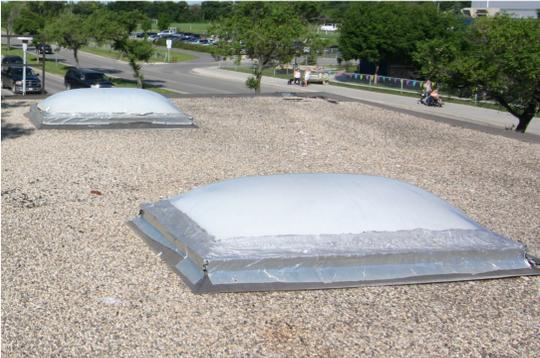
EXISTING RECTANGULAR SKYLIGHTS

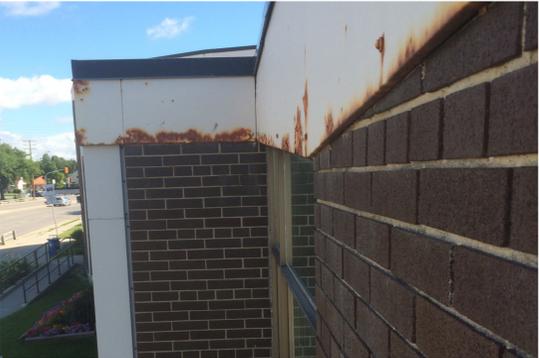
EXISTING WHITE FASCIA ALONG NORTH ELEVATION, RUST INDICATES MOISTURE DAMAGE

The historic white fascia is a decorative element of the building and a Heritage defining element. Areas of the fascia are currently rusted and deteriorated. This fascia will be removed, cleaned, reinstalled or repaired and painted in the overall refresh of the building.

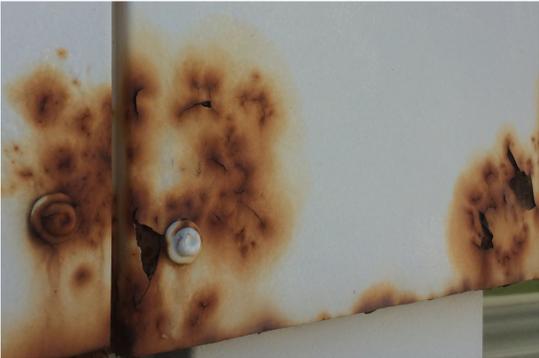
DETAIL OF EXISTING FASCIA SHOWING SIGNS OF RUST

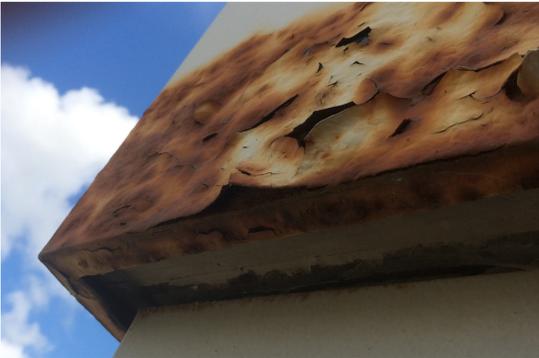
DETAIL OF EXISTING FASCIA SHOWING SIGNS OF RUST

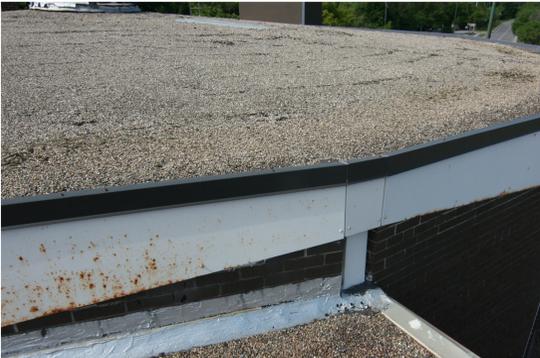
EXISTING FASCIA AT ROOF TRANSITION
