FACILITY REPAIR & RESTORATION:

EXISTING CONDITIONS TO BE REPAIRED & RESTORED

ST. VITAL PUBLIC LIBRARY

6 FERMOR AVENUE

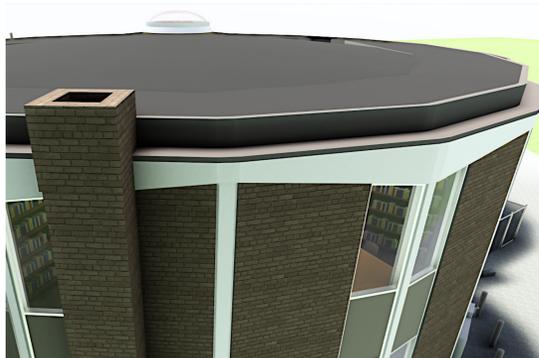
PROPOSED HIGHLY INSULATED ROOF (HIGH ROOF)

New roofing is an important upgrade of the 2016 renovation and will improve library building sustainability. The new roof will also allow the library to meet current standards for roof insulation values.

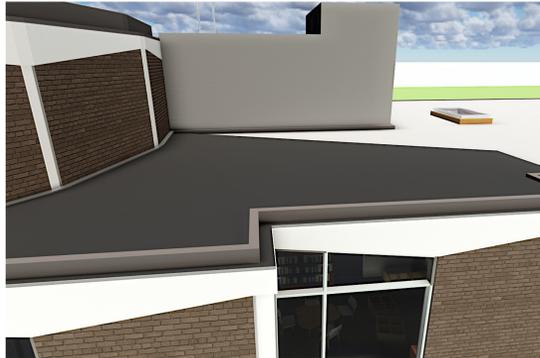
PROPOSED HIGHLY INSULATED ROOF (LOW ROOF)
